USER MANUAL –  
FPSO/FSU

RAPID  
RESPONSE  
DAMAGE  
ASSESSMENT

September 2019

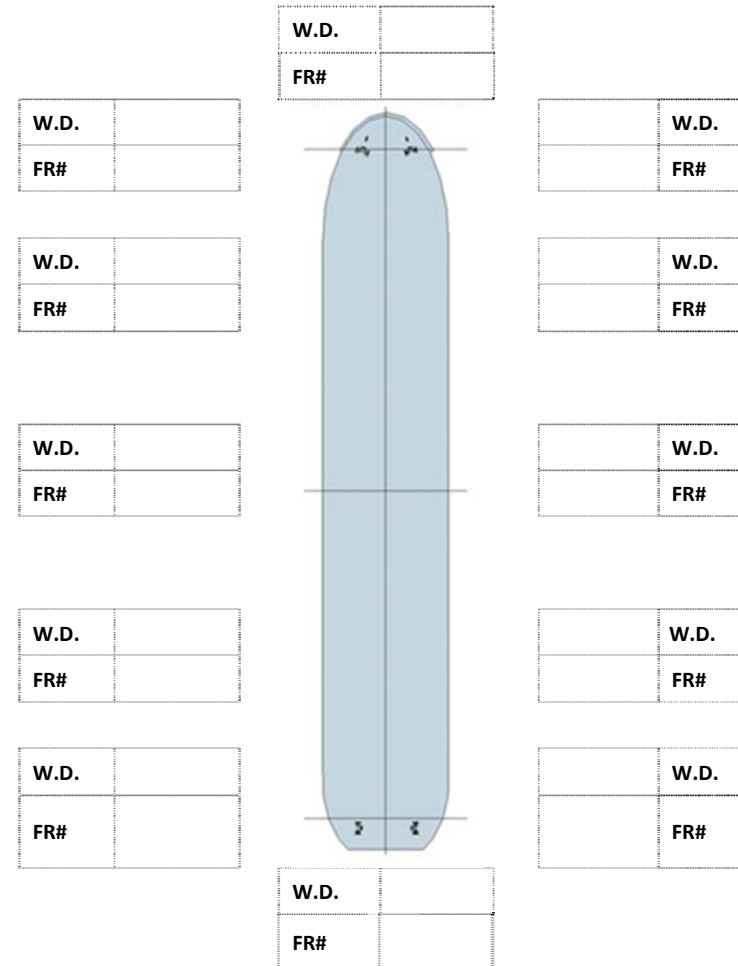
<b>Facility Name:</b>			
<b>Date:</b>			
<b>1. Drafts - Aground</b>			
<b>Units</b>	Meters	Feet	
<b>Time</b>	-hrs.	Local	UTC
--	Forward	Amidships	Aft
<b>Port</b>			
<b>Starboard</b>			
<b>List of Heel</b>		Degrees	P S
<b>2. Approximate Area of Ground Contact</b>			
Outline the approx. contact area on the hull outline.			
<b>3. Provide water depths (W.D.)</b>			
Water depth values to the extent needed.			
Measured by a boat or tug?			
Measured from ship's deck?			
<b>4. Facility Heading</b>			
			-Degrees (T)
