Best Practices for Operation of Ballast Water Management Systems

Identified during ABS 2nd BWMS Workshop, Houston

American Bureau of Shipping

Date: August 10, 2017

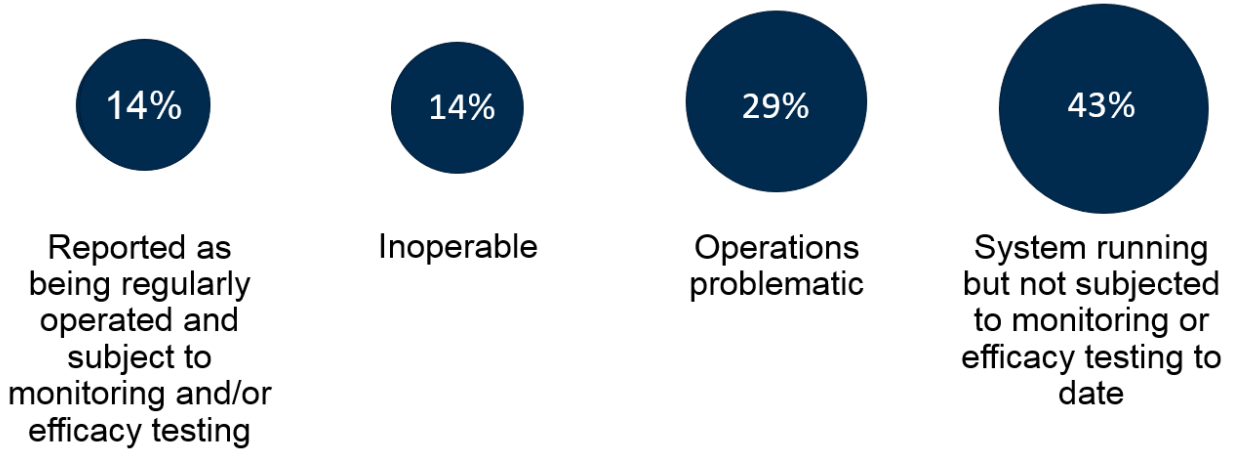
Figure 1 BWMS Operability

The results from the questionnaires were imported into an excel spreadsheet with the quantifiable items, such as dates and sizes, refined and made sortable. If not initially indicated, the descriptive sections were deciphered and interpreted to support a more comprehensive analysis. Depending on the categorization, data was pulled into numerical terms and presented graphically. A more detailed analysis can be found in Appendix A.

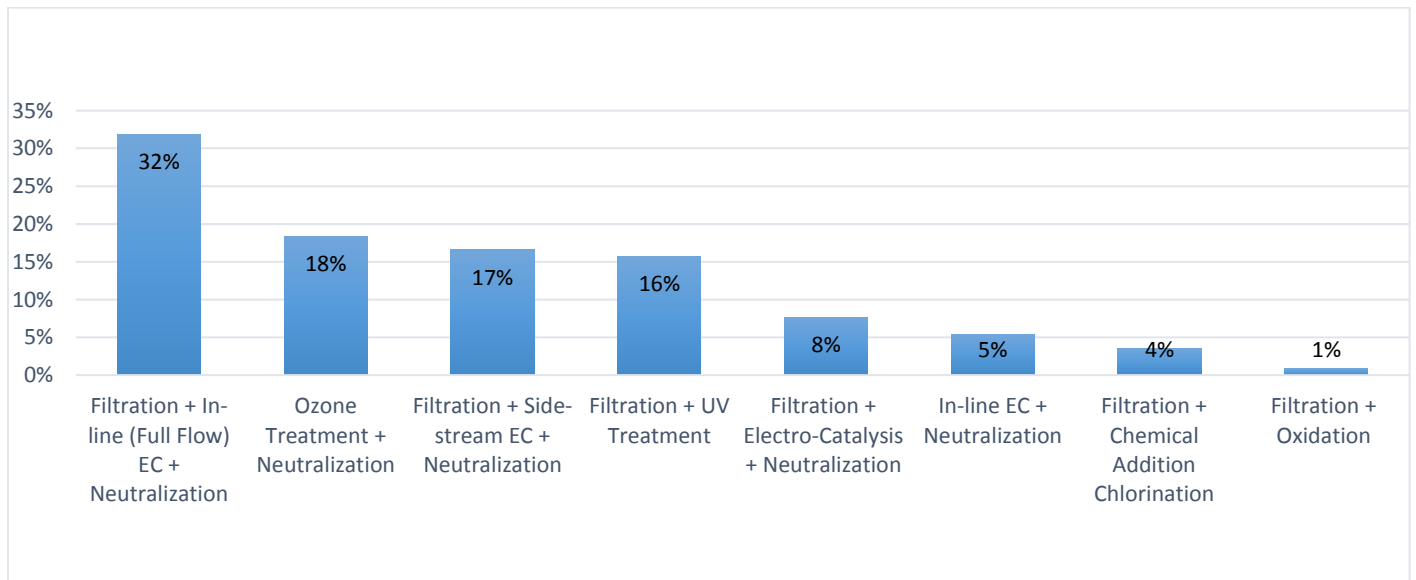
Figure 2 Technology Types

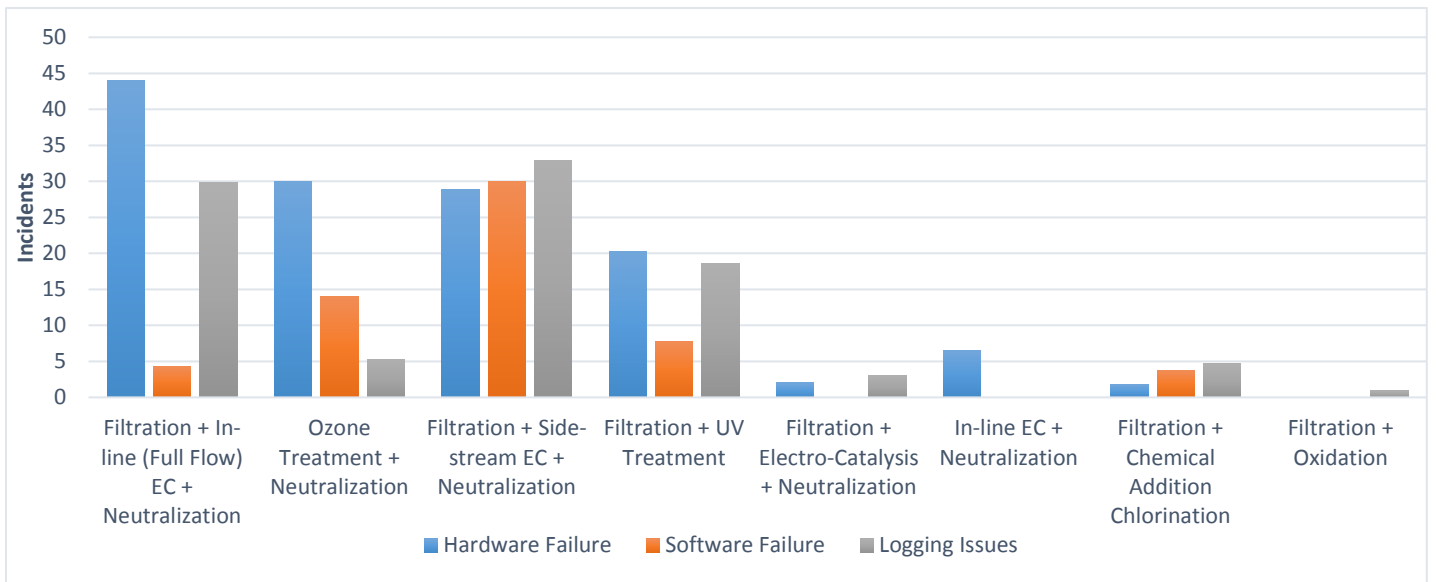
Figure 3 Operational Incidents Reported

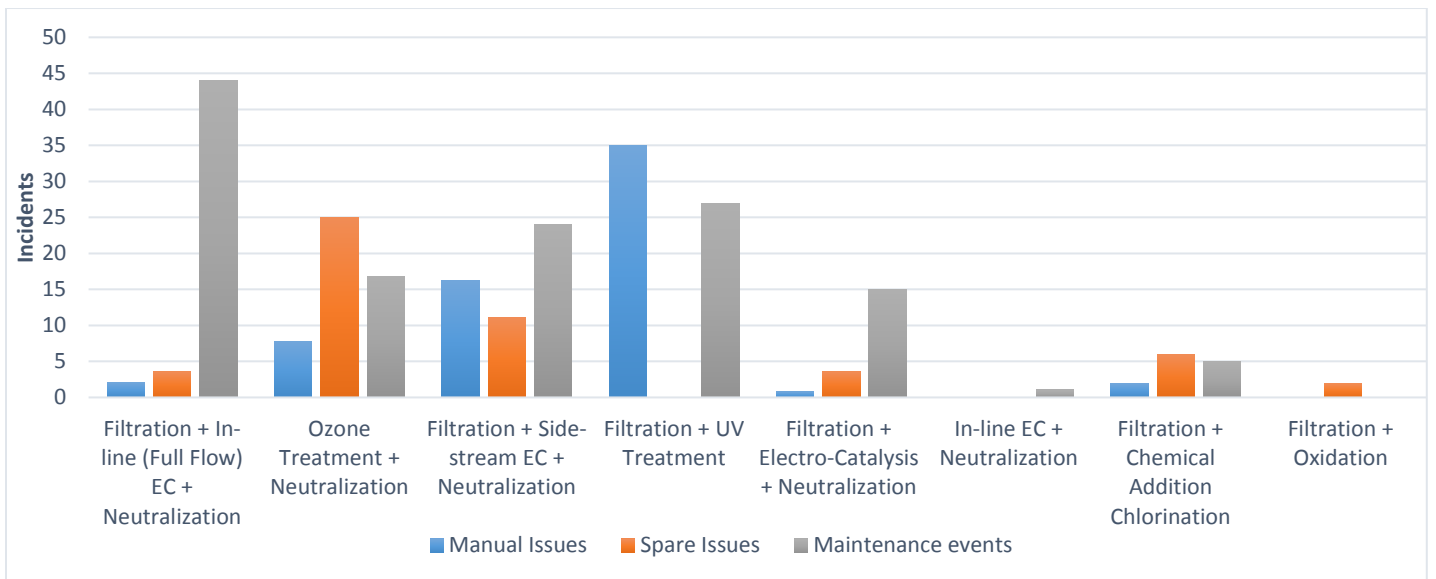
Figure 4 Maintenance Incidents Reported

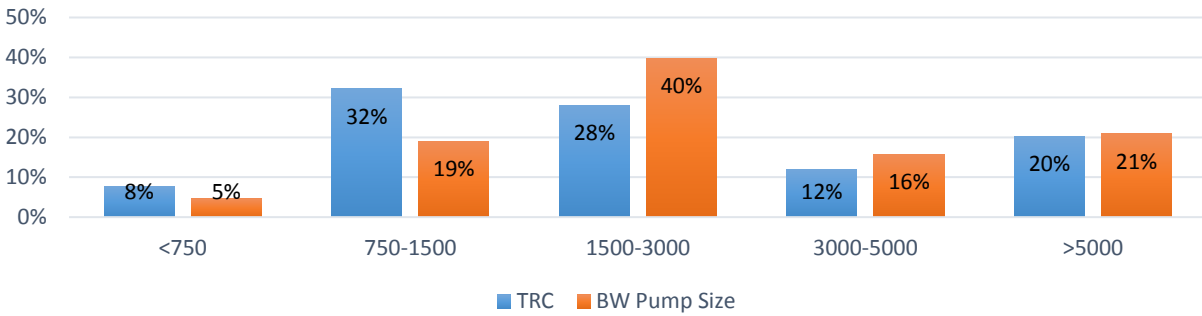
BW Pump Size and Treatment Rate Capacity (TRC) (m³/hour)

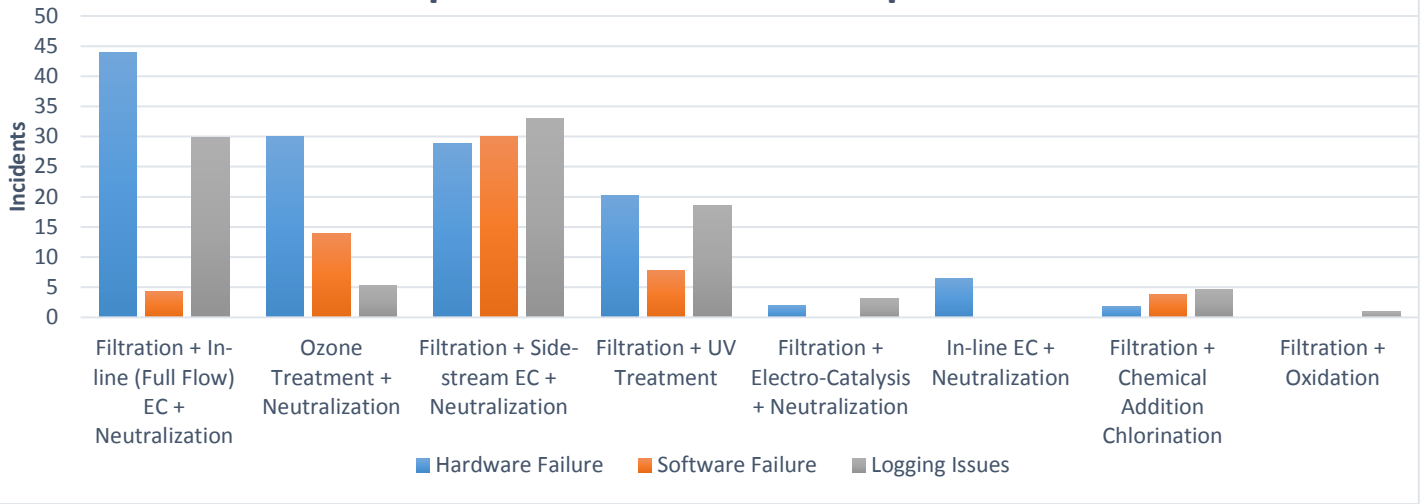
Operational Incidents Reported

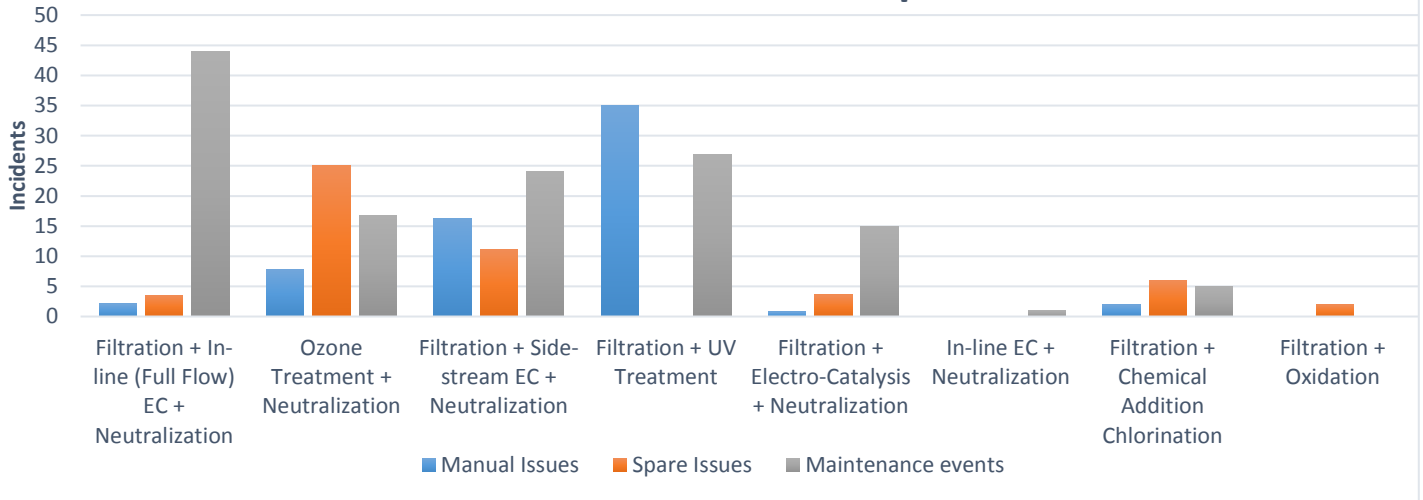
Maintenance Incidents Reported
